Yucca Mountain Site Operations Update

Presented to:
Nuclear Waste Technical Review Board

Presented by:
Scott A. Wade
Acting Director, Yucca Mountain Site Operations Office

January 24, 2007
Las Vegas, NV

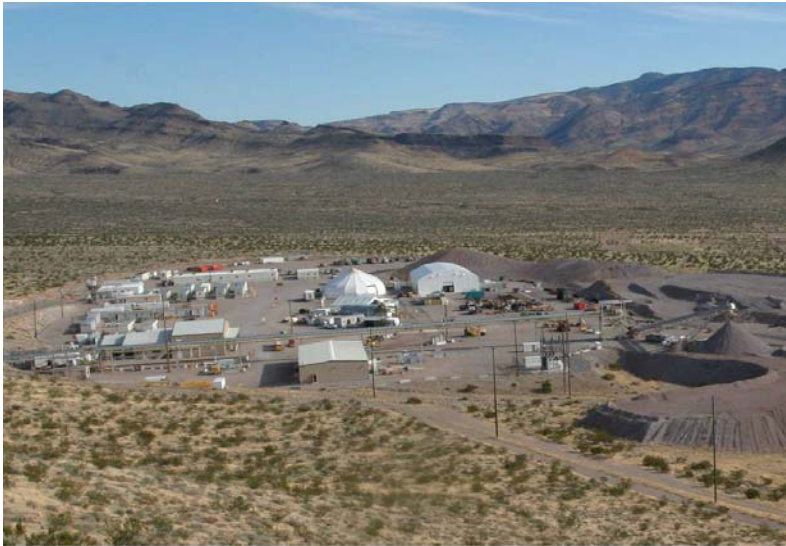
Current ESF Site Facilities

North portal facilities

- **Two permanent structures**
- **121 temporary structures**
 - Trailers
 - Cargo containers
 - Tents (fabric covered)
- **About 185 full time employees**

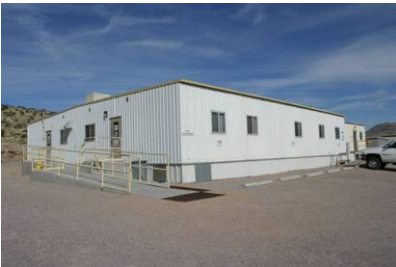
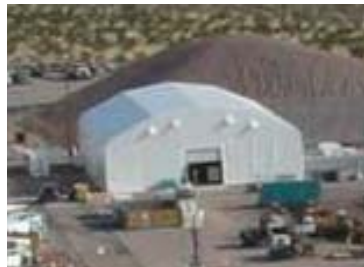
ESF Site Facilities - Current Condition

- Warehouse and craft metal fabrication functions located in tent structures on the north portal pad
- Other craft activities performed under corrugated metal sunshades
- Craft work environment not climate controlled
- Aged and deteriorating office space for staff
- 45-minute minimum response time for fire & rescue services

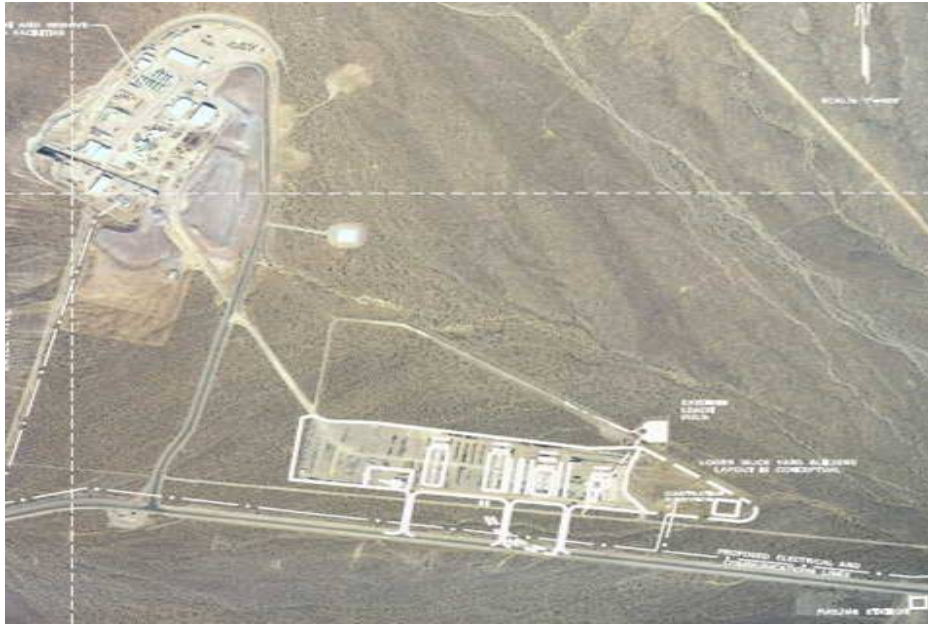
Lower Muck Yard Complex - Proposed Plan

- **Draft Environmental Assessment examines alternatives to relocate ESF warehouse and craft shops to proposed structures adjacent to the north portal pad on previously disturbed land**
- **Proposed Action Considers:**
- **Construct and equip new medical and fire station (8,000 ft²), and heavy equipment maintenance shop (8,000 ft²)**
- **Construct craft, warehouse, and administrative facility (approx. 30,000 ft² each)**

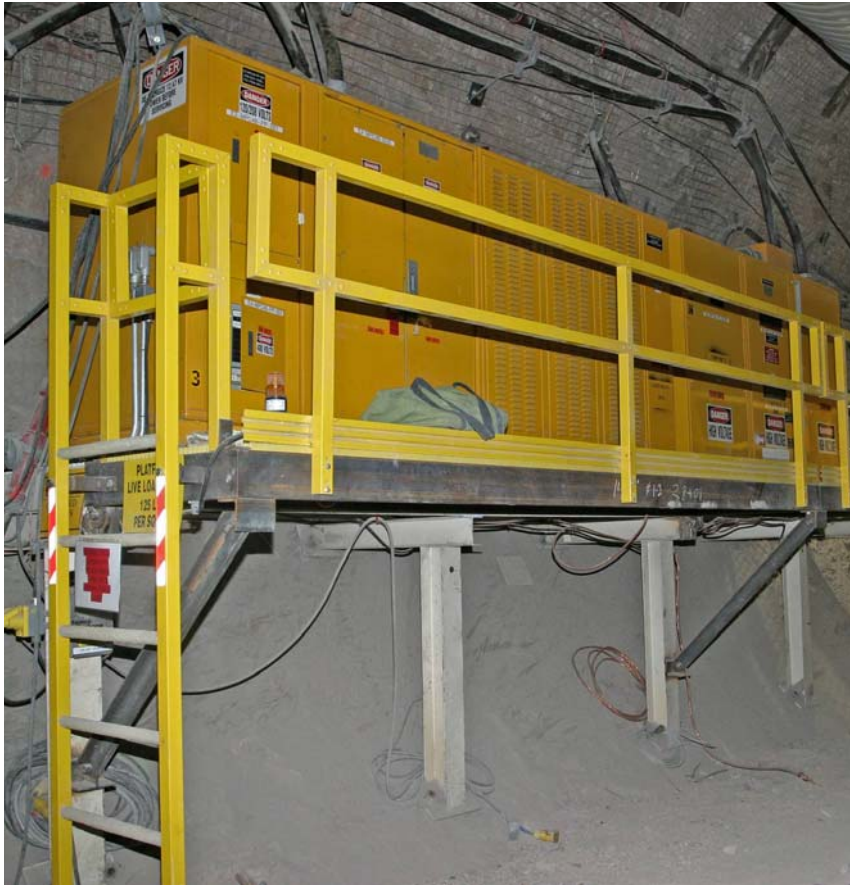
Underground Electrical System – Mine Power Centers (MPC)

- **Preventive maintenance completed in FY 2005**
- **Back panels still inaccessible for repairs**
- **Clearance issues with trains in tunnel**
 - **Speed restrictions in proximity to MPC platforms**

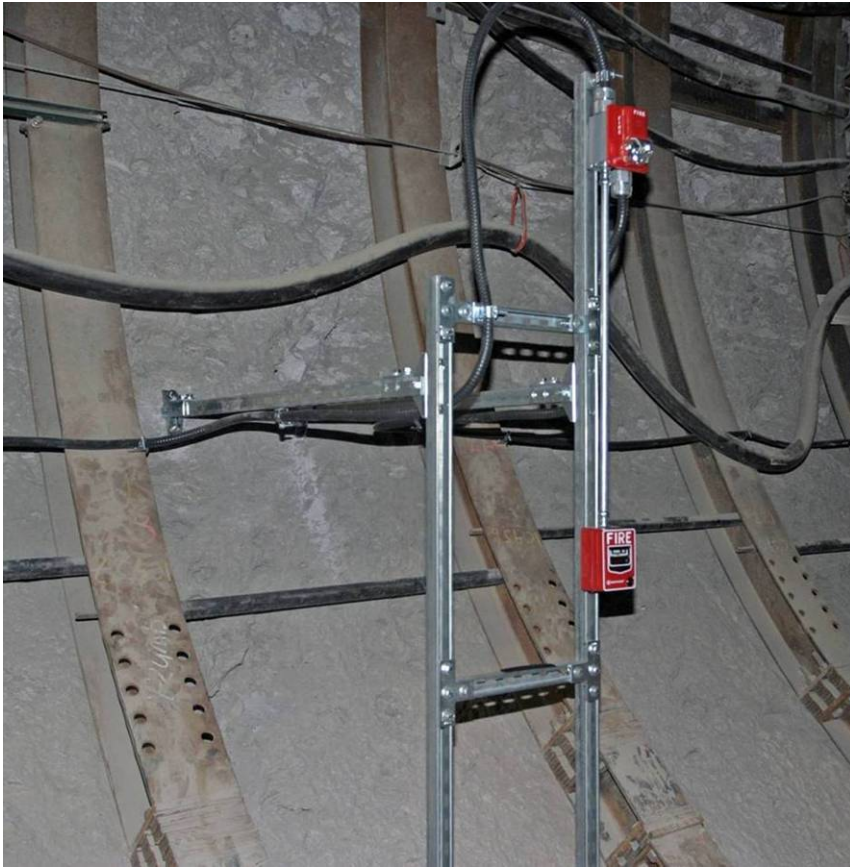
Underground Fire Alarm and Detection System

- Serves as a means of detecting underground fire, providing notification to personnel
- Need identified in a 2004 fire hazards analysis
- Satisfies the requirements of National Fire Protection Association 72 and 502
- Installation completed in North Ramp, ECRB* and Alcove 5
- Remaining sections of system will be installed in 2008

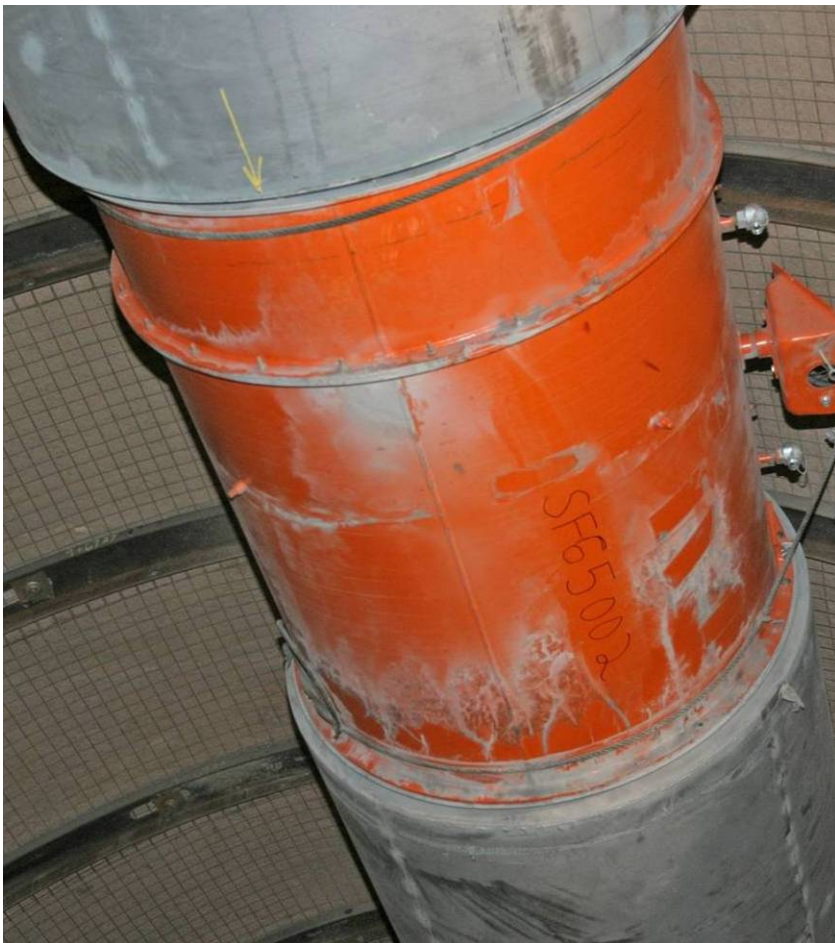
Underground Ventilation Improvements

- A 2004 assessment recommended modifications to the ventilation system and implementation of a maintenance/repair program
- Temperature and vibration monitors installed on fans
- Fan 10 and 11 planned for replacement

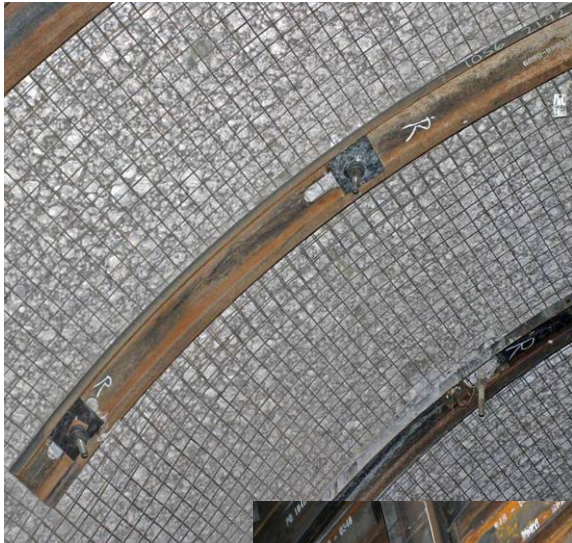
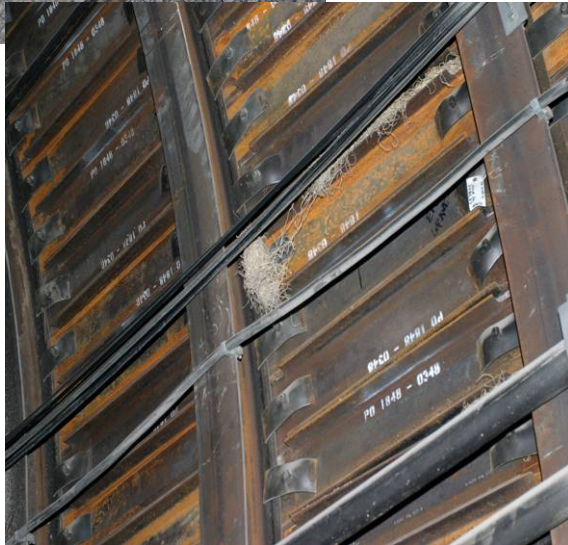
Ground Support

- **System assessed in 2004**
- **Implemented additional ground support controls in certain areas**
- **Implemented a rockbolt maintenance program**
- **2004 Fire Hazard Analysis recommended grout of eight 3.01X areas to lower fire load**
 - **Safety mitigations in place in these areas to reduce fire risk**

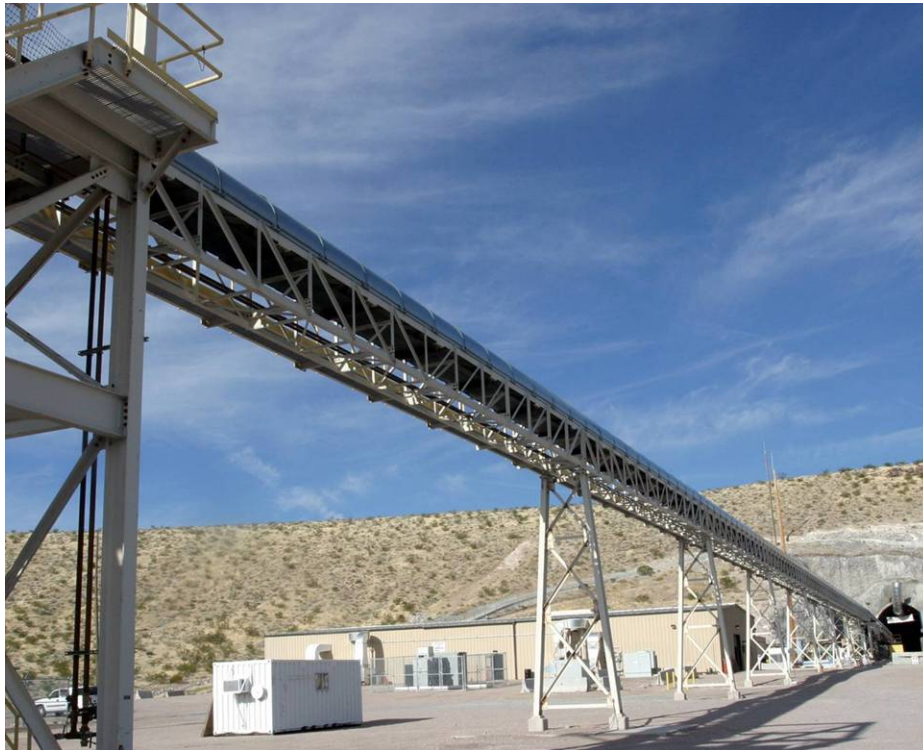
Conveyor System

- To reduce the fire load underground and improve safety, removal of the tunnel boring machine muck conveyor system was recommended in three phases:
 - Belt removal
 - Surface Sections removal
 - Subsurface Sections removal
- Surface structure and belt and ECRB cross drift belt removed

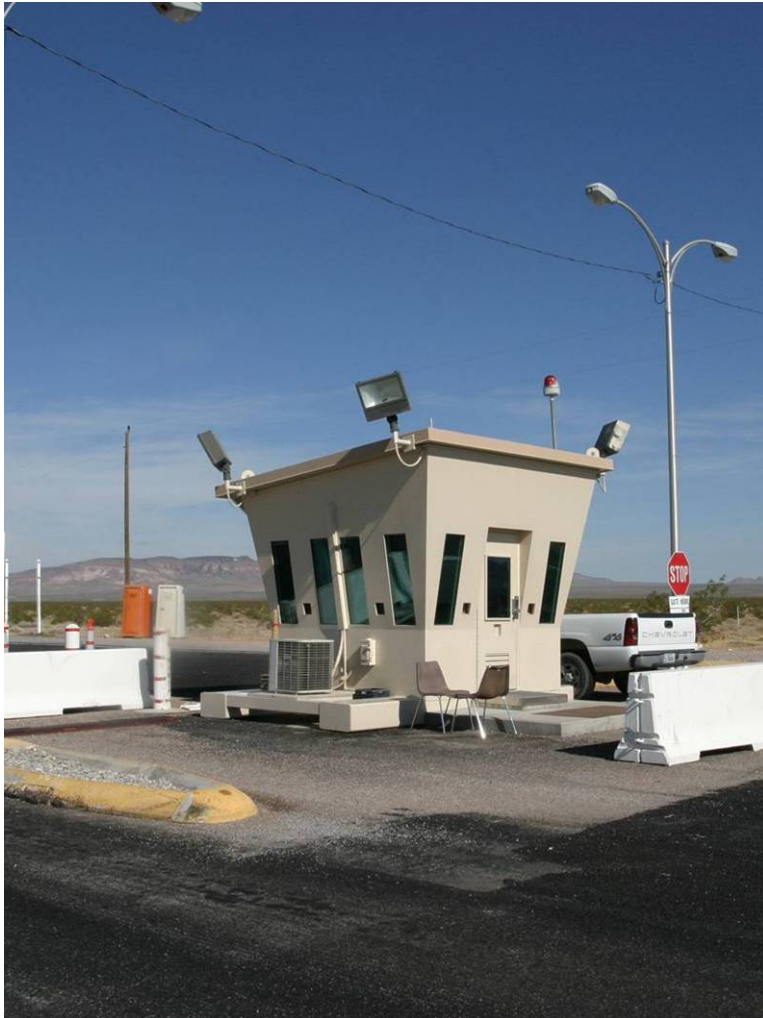
Gate 510 – Current Condition

- **Entry point for site work staff and visitors with very limited functionality**
- **No badging capabilities**
- **No site access control capabilities**

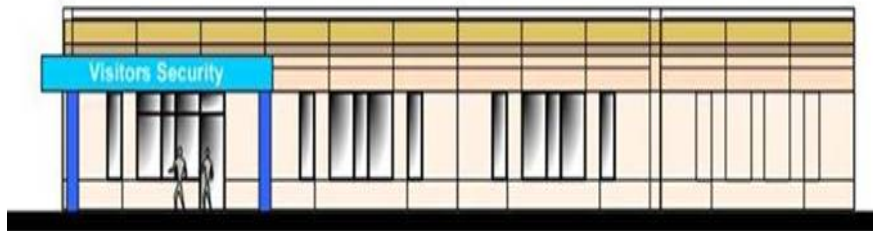
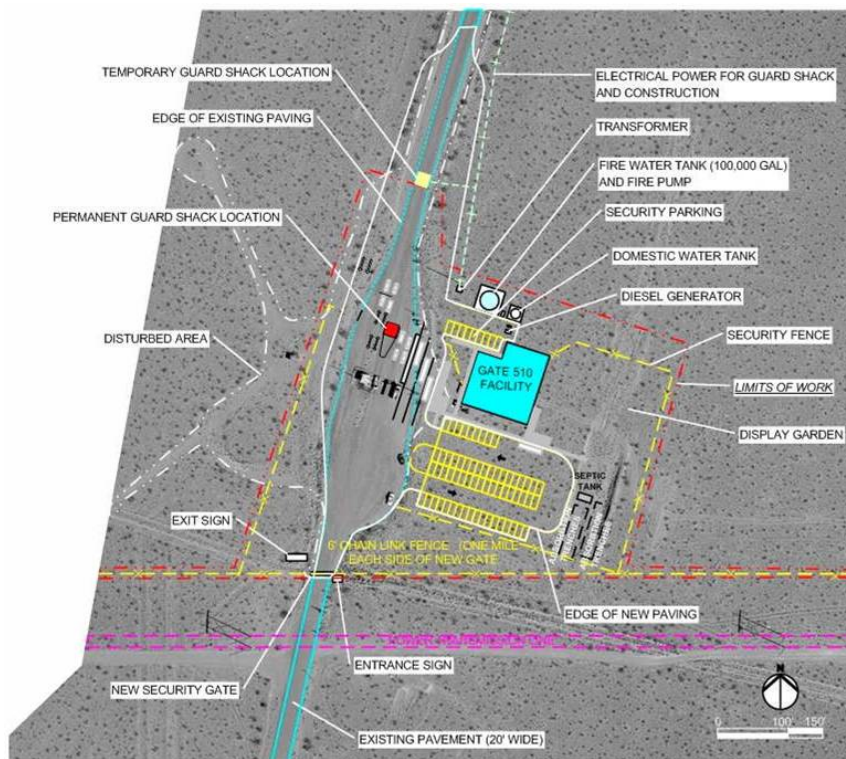
GATE 510 FACILITY - PROPOSED SITE PLAN

- Construct new approx. 9,000 ft² facility at the existing Gate 510 location
- New Gate 510 facility functions include:
 - Enhanced security and access control
 - Badging
 - Site access control
 - Site access training and training verification
 - Backup emergency operations center supporting current activities
 - Hazardous material tracking

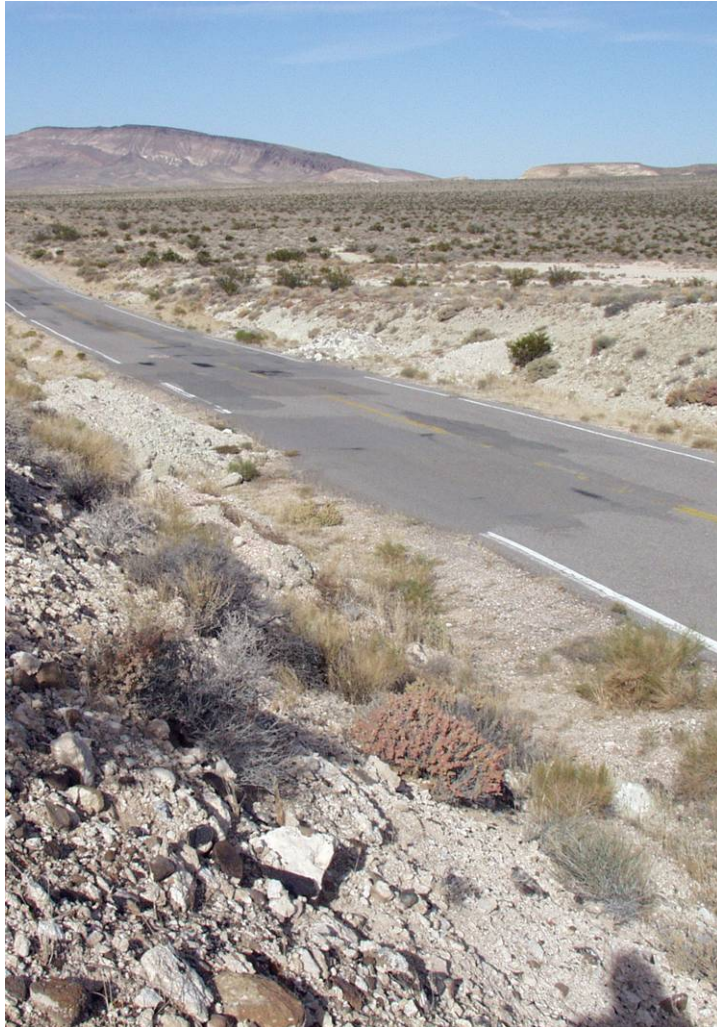
Site Access Road – Current Condition

- **Constructed in early 1960s**
- **Hill and dale construction means with minimal sub-bed**
- **Deteriorating asphalt surface**
- **Poor drainage**
- **Increasing maintenance and repair needed**

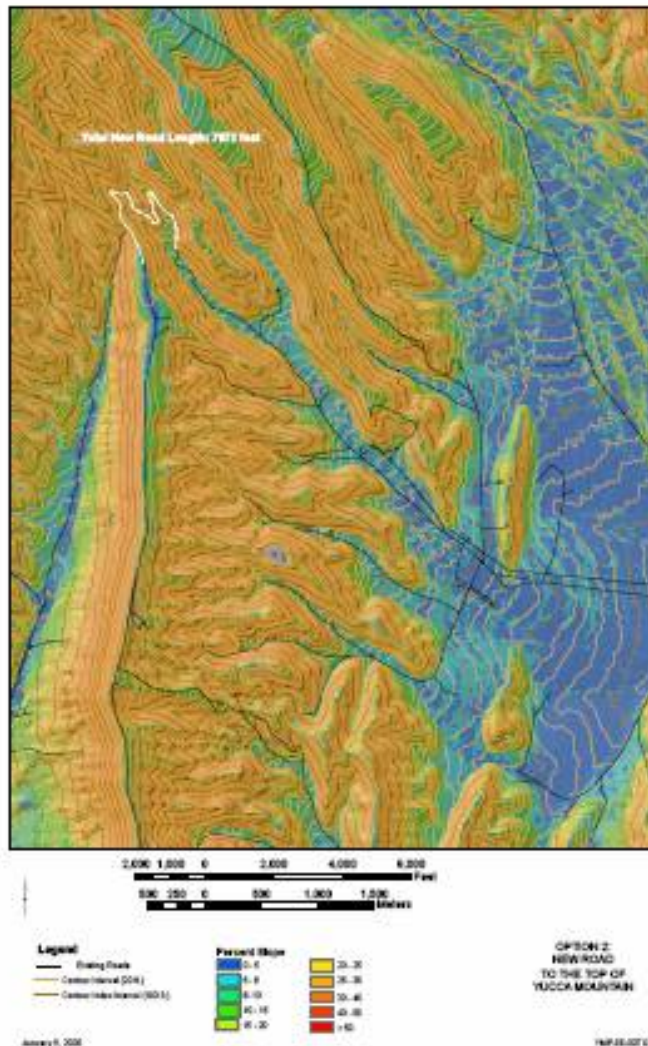
Yucca Mountain Proposed Crest Road Improvements

Existing crest road is unpaved with grades up to 23%

- **Draft Environmental Assessment examines alternatives to develop a new 1.3 mile crest road connection maintaining a <8% grade**
- **Connects with existing paved “H” road in vicinity of sub-dock area near north portal and intersects with road at the crest**
- **Chipseals road along Yucca Mountain crest**

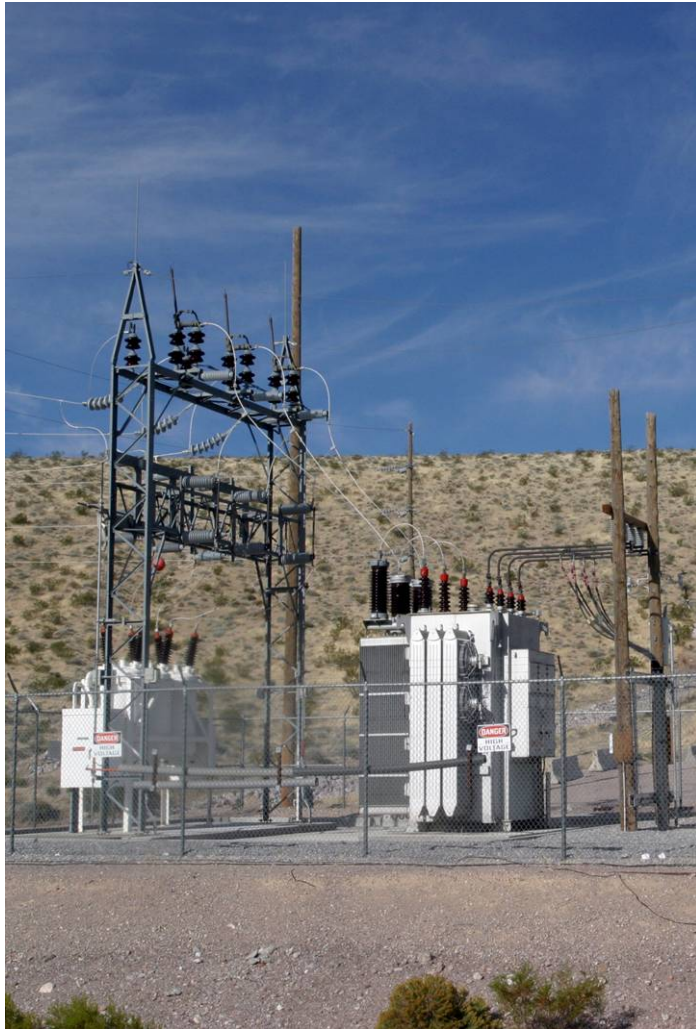
Offsite Power to the ESF– Current Conditions

- **Current power provided by 69 kV line from the NTS Grid**
- **Only remaining 69 kV line on the NTS**
- **Limited to 10 MW total power**
- **Single-point failure**

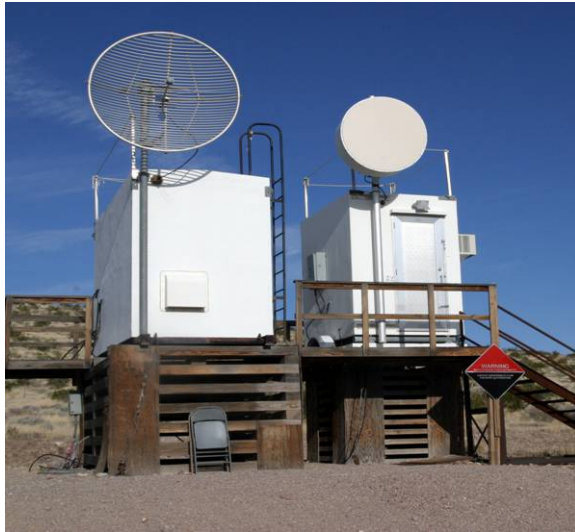
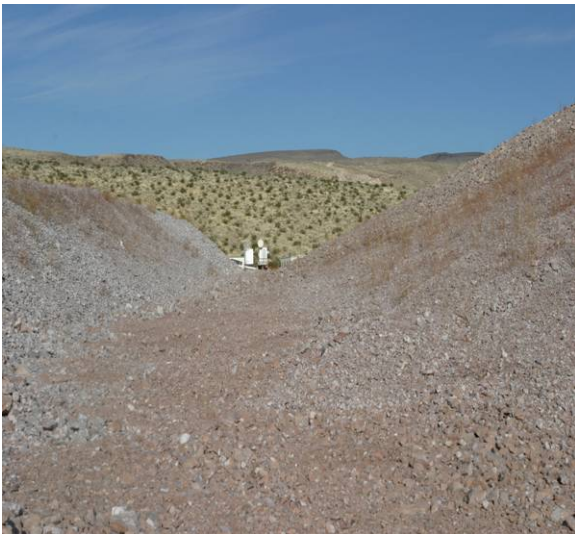
Communication System – Current Conditions

- **Currently provided via analog microwave transmitter at north portal pad and interfaced with Nevada Test Site microwave system**
- **Functioning at maximum operating rate of 1 Mb**
- **Extremely slow**
- **Single-point failure**

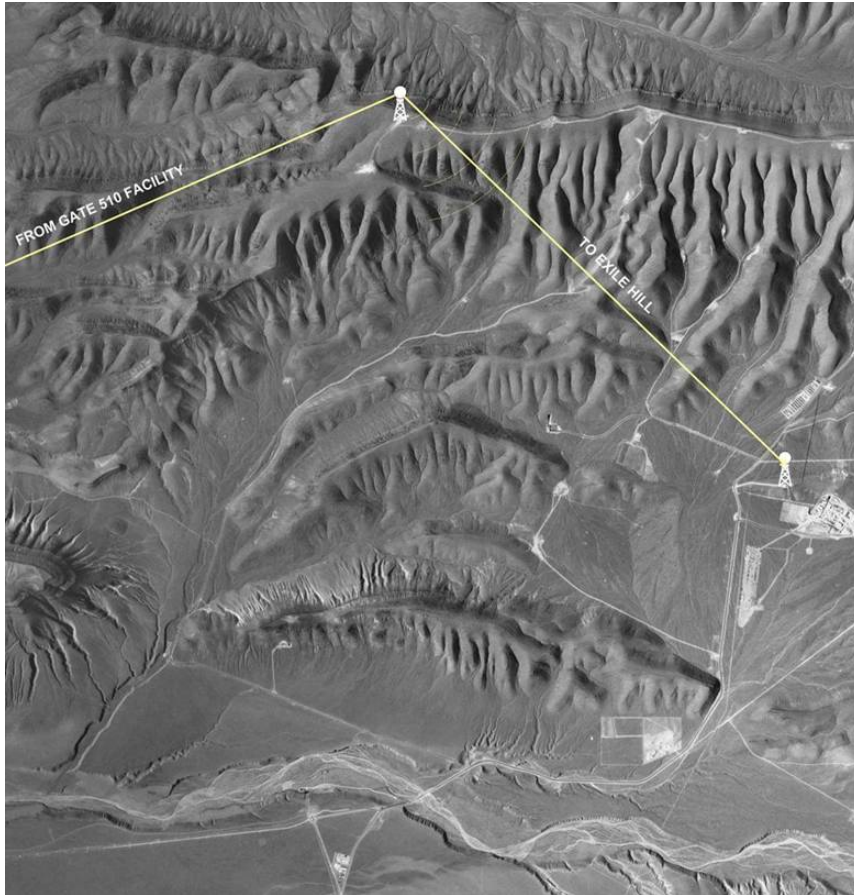
Communication System Upgrades

- **Constructing new digital microwave transmitter system**
- **Towers to be installed at Exile Hill, Yucca Crest, and Gate 510 with interface with fiber optic line at Lathrop Wells.**
- **Increased transfer rate to 40 Mb**
- **Eliminate single-point failure**
- **Estimated completion in March 2007**

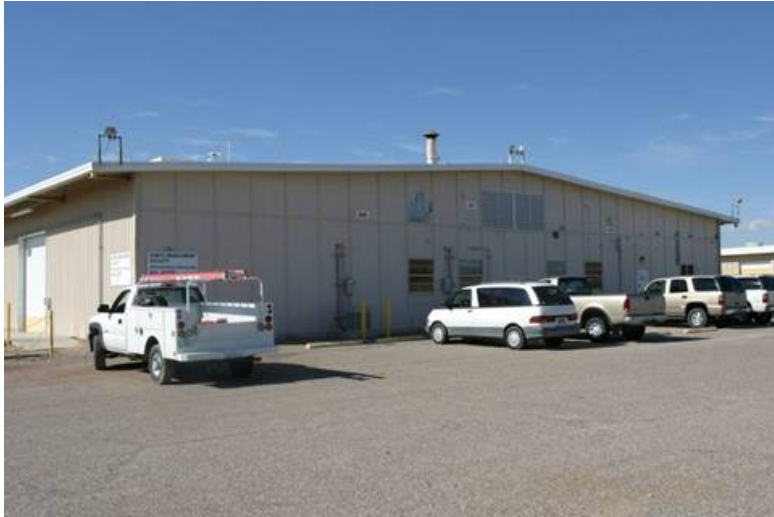
Sample Management Facility

- **Built in mid-1960s**
- **Currently at maximum capacity**
- **Rapidly deteriorating due to age**

- **Locate a facility for lease outside the boundaries of the Nevada Test Site**
