Memo

To: Bob Halstead
From: Marvin Resnikoff
Date: 12/17/2013
Re: NUREG-2125 Review

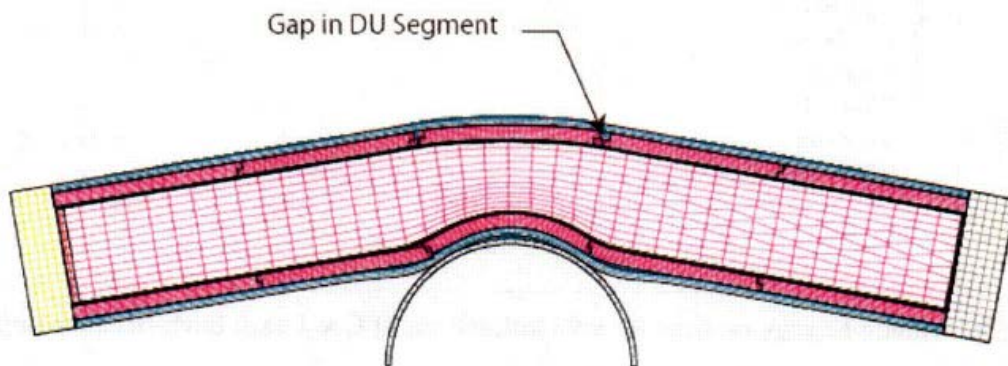
Figure 34. GA-4 cask after 96 kph [60 mph] back-breaker impact.

The back-breaker scenario was considered in the Package Performance Study¹ (PPT) (see Fig. 34 below). The NRC claimed “the level of strain was not high enough to cause tearing of the containment boundary and there was no permanent deformation in the closure region and no loss of containment.” No “permanent deformation” does not mean “temporary displacement” when bolts stretch. As discussed below regarding the interaction of an engine train sill and cask, the bolts can stretch and the opening of the cask lid can indeed remain open. Other details, such as the internal pressure also need to be considered.

As seen in Fig. 34, the interior of the cask was modeled as a solid composite, rather than as individual fuel assemblies, shown in the cross-section of the GA-4, Fig. 1. In addition, the ends of the cask were not modeled to include impact limiters which add one-ton weights to each end of the cask, similar to a barbell.

Most importantly, the bolts and cask cover were not modeled in detail in the PPT, so it is not possible to state that there was “no loss of containment.” A stretching of the bolts would allow gases and fine particles to be released. Without detailed modeling of the bolt region, it is not possible to state “permanent deformation” could not occur.

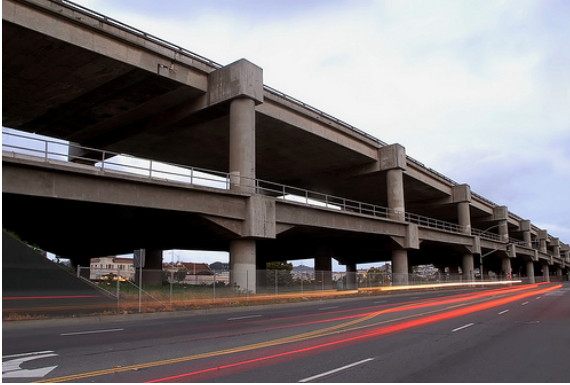
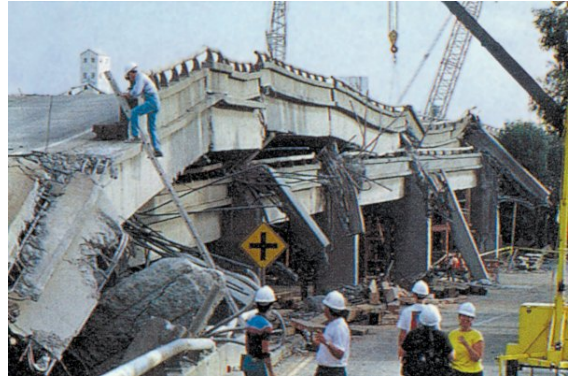
Fig. 3. Cypress Street Viaduct Before and After Collapse

The Cypress Street Viaduct was a 1.6 mile long, raised two-tier, multi-lane (four lanes per deck) freeway constructed of reinforced concrete that was originally part of I-880 in Oakland, California. It officially opened to traffic on June 11, 1957 and was in use until the 1989 Loma Prieta earthquake, when much of the upper tier collapsed onto the lower tier due to poorly designed bridge columns. Fig. 3 below shows the before and after of the Loma Prieta earthquake.
